## Realigning an elevation switch on an Oyster system

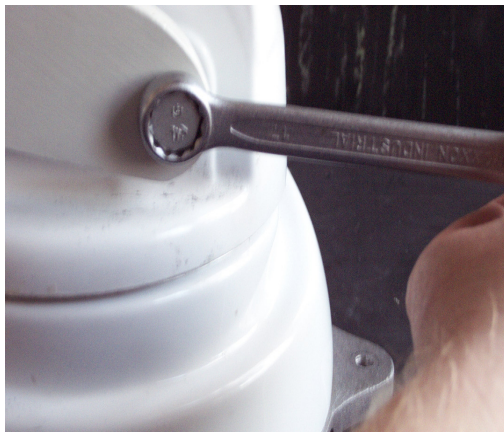
This procedure will become necessary when the Oyster displays an “initialisation error” or “Initfehler” (Vison3) or “searching for Top Box / No Top Box found” or “E05 (Oyster Digital).

All these error message mean is that the elevation switch is not triggered. This is an easy fix and can easily be performed by the customer on site. A 17mm spanner, a small piece of cardboard (spacer) and access to the Top box / roof unit is necessary!

1. Make sure the system is switched off or in standby (Oyster Digital / green dot)
2. On the roof, remove the 2 black plastic bolt covers left and right of the turret and loosen the bolts underneath, using a 17mm spanner.
